FANNON, BRIAN R., PhD. Beaver Dam Features Influencing Stream Channel Form in the Mountain and Piedmont Physiographic Provinces of North Carolina (2015)

BEAVER DAM FEATURES INFLUENCING STREAM CHANNEL
FORM IN THE MOUNTAIN AND PIEDMONT
PHYSIOGRAPHIC PROVINCES OF
NORTH CAROLINA

A Dissertation Submitted to
the Faculty of The Graduate School at
The University of North Carolina at Greensboro
in Partial Fulfillment
of the Requirements for the Degree
Doctor of Philosophy

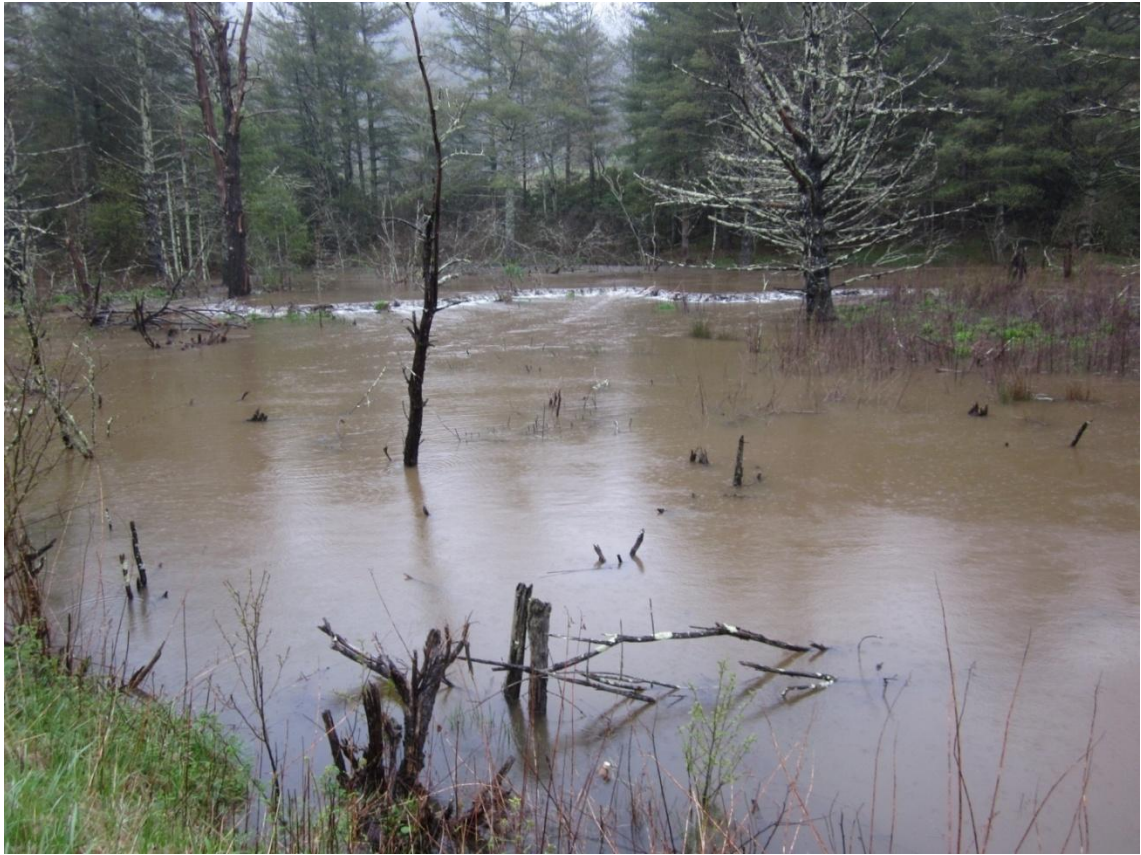
Figure A17. Dam above Donald Barrier Street during High Flow, May, 2013, demonstrating Extent of Dam. (Author)

The area just above Donald Barrier Road consisted of a large shallow pond with a low dam, approximately 1 meter tall, 1.75 m wide and 100 m long upon the first site visit in 2012. During a high flow event in 2013 the dam was overtopped, which provided clear visible evidence of its extent (figure A17.)

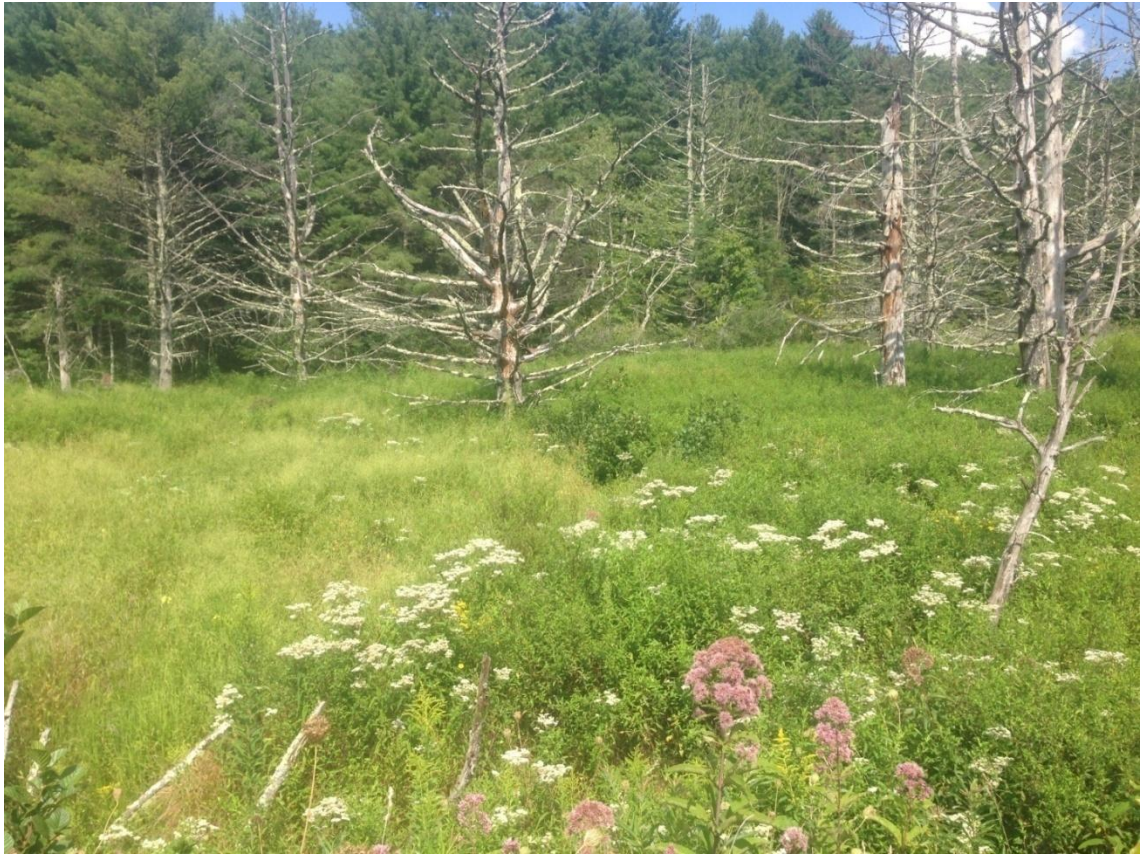
This dam was maintained until Spring 2014, when beaver activity in the area ceased. Over the next year, the pond drained and the area transitioned to a well-vegetated bog area (figure A18), with Hazel Alder (*Alnus serrulata*) being the first (and as of this writing, only) woody plant species to colonize the area. This meadow now contains 5 LWD piles, 3 check dam remnants, 3 running stream channels and 5 ephemeral channels, plus the original dam is largely intact and now well-vegetated.

Figure A18. Camp Creek Site, August 2015. Note dead Hemlock (center) as reference to Figure A17. (Author)

Figure A19 illustrates this area in a 1994 aerial view, before significant beaver activity in the area. The road in the center is Donald Barrier Street; note that the majority of the area is wooded. Figures A17 and A18 were taken upstream of the bridge (right side in figures.)

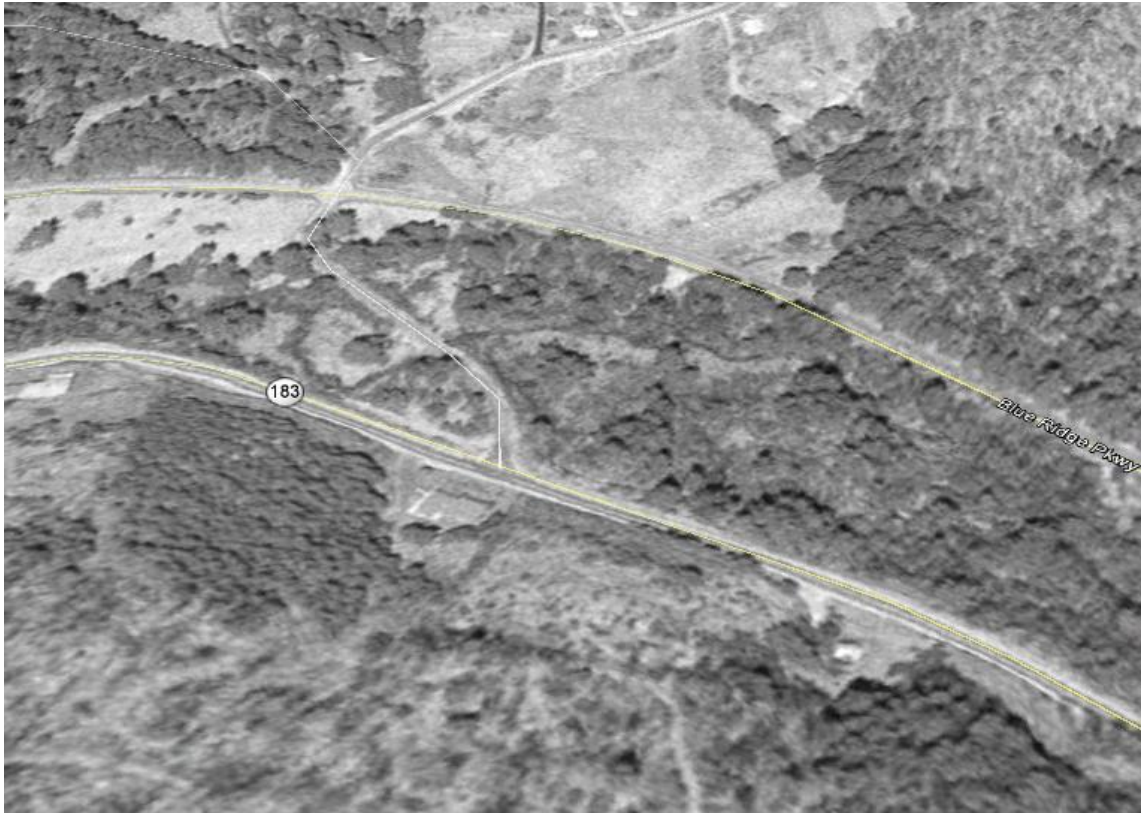
Figure A19. 1994 Aerial Photograph of Donald Barrier Street Area. (Google Earth)

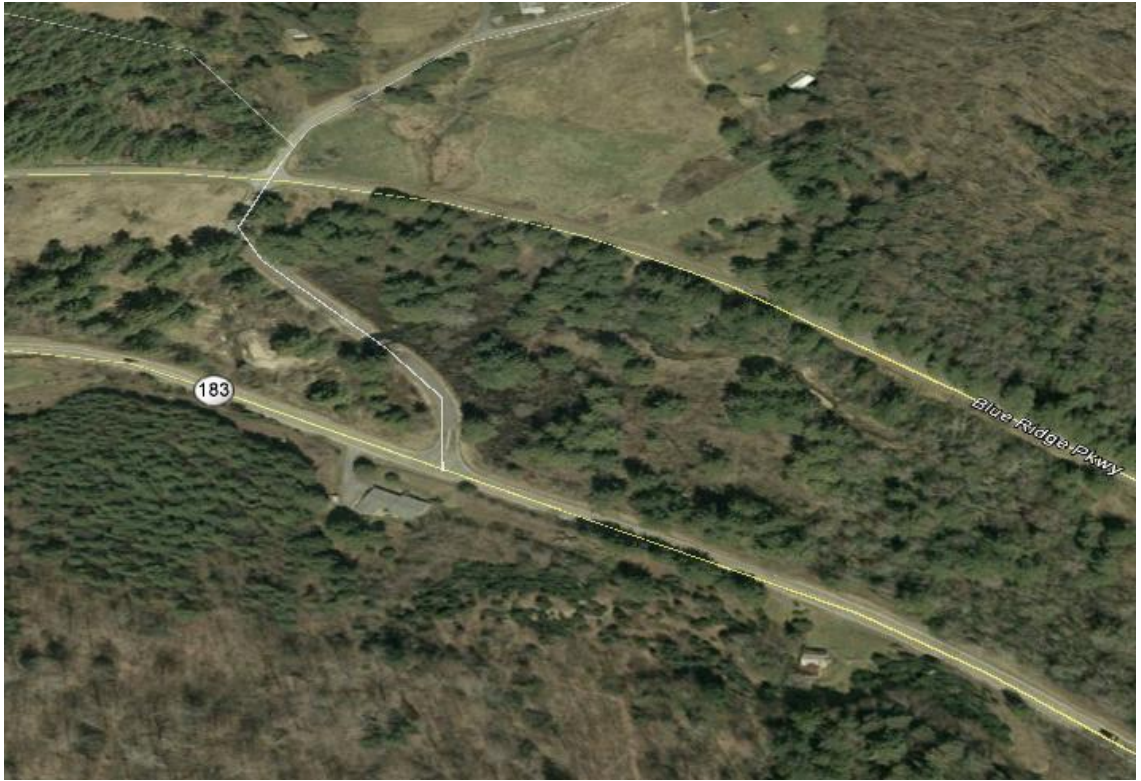
By 2005, beaver activity has created a wide pond across the area, resulting in some loss of trees (Figure A20), and by 2013 the pond is quite extensive with continued tree loss due to beaver predation and inundation (Figure A21.)

Figure A20. 2005 Aerial Photograph, Donald Barrier Street Area. (Google Earth)

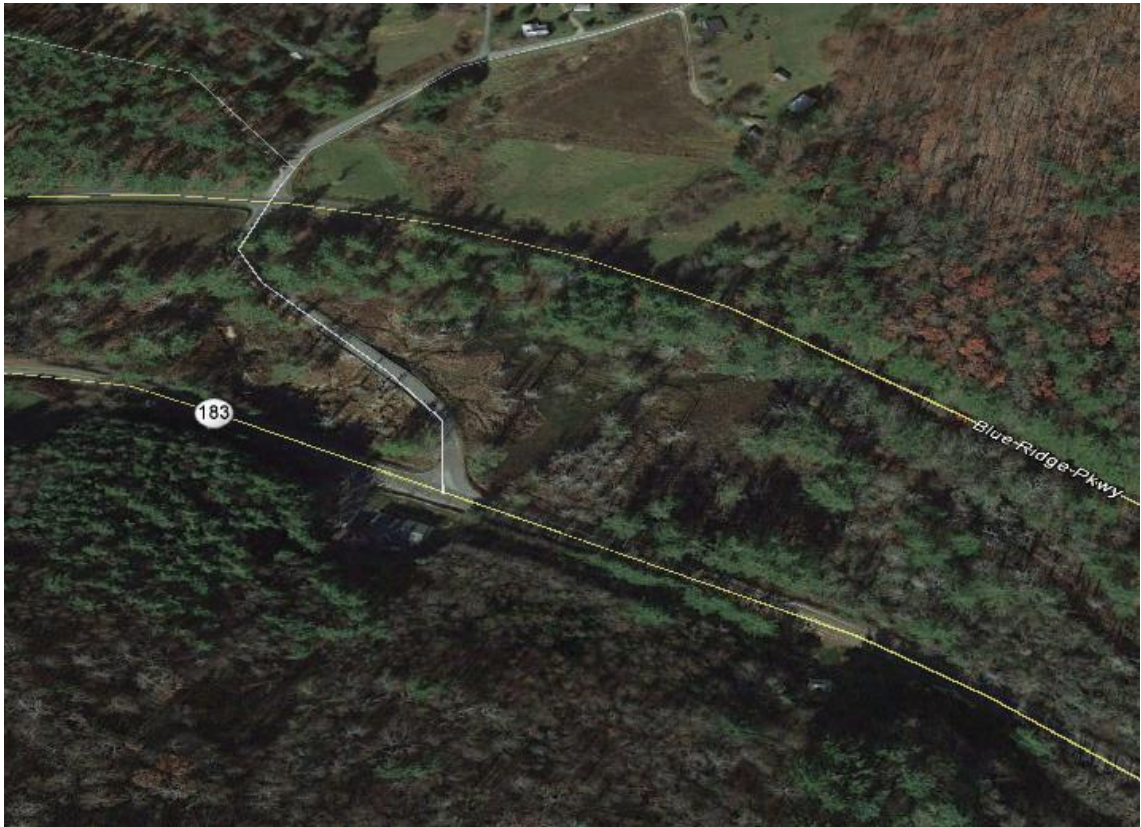
Figure A21. 2013 Aerial Photograph of Donald Barrier Road Area. (Google Earth)

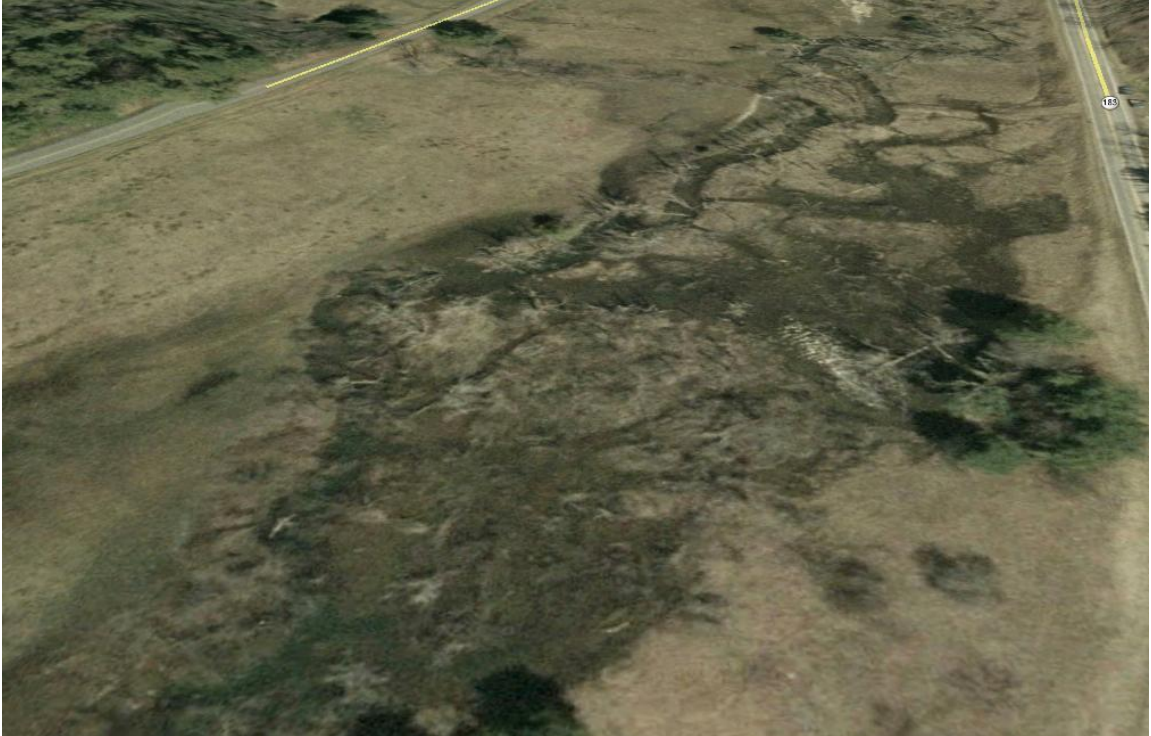
The lower reach of impacted area was abandoned in 2010, and no activity was noted after that time. As figure A22 shows, by 2005 the area had been subject to intensive beaver activity for some time, with no large trees and minimal shrubs visible. Numerous channels are also visible in this view. By 2010,

Figure A22. 2005 Aerial Photograph of Site M3 Lower Reach. (Google Earth)

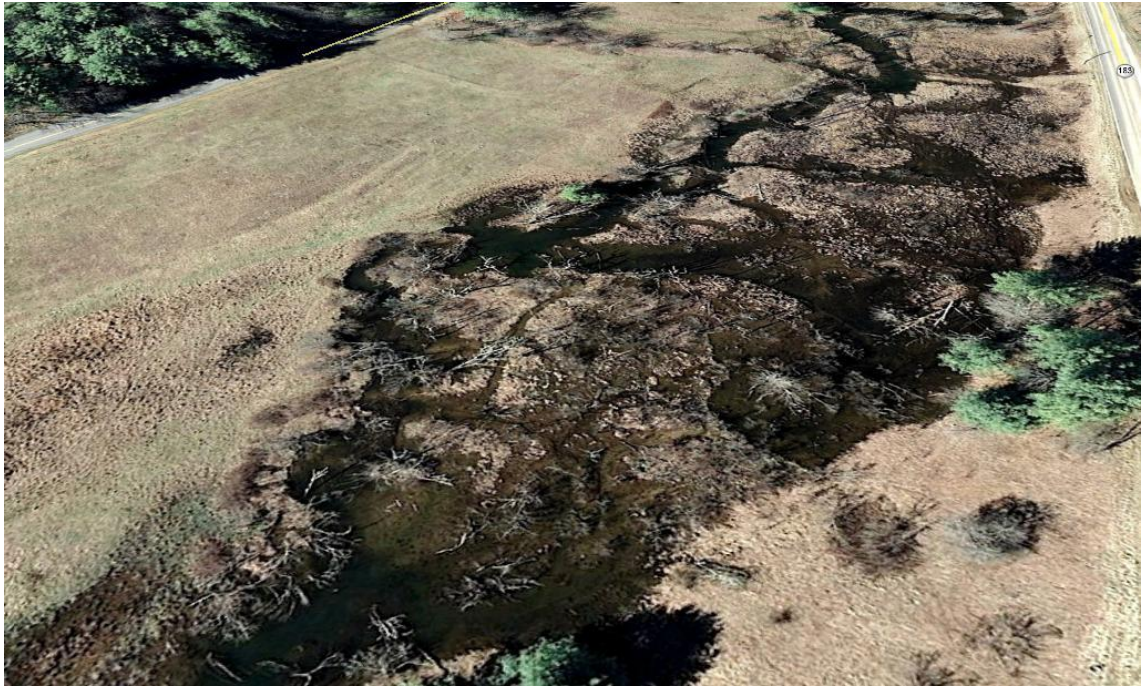
inundation has increased and channels have become more clearly defined
(Figure A23.)

Figure A23. 2009 Aerial Photograph of Site M3 Lower Reach. (Google Earth)

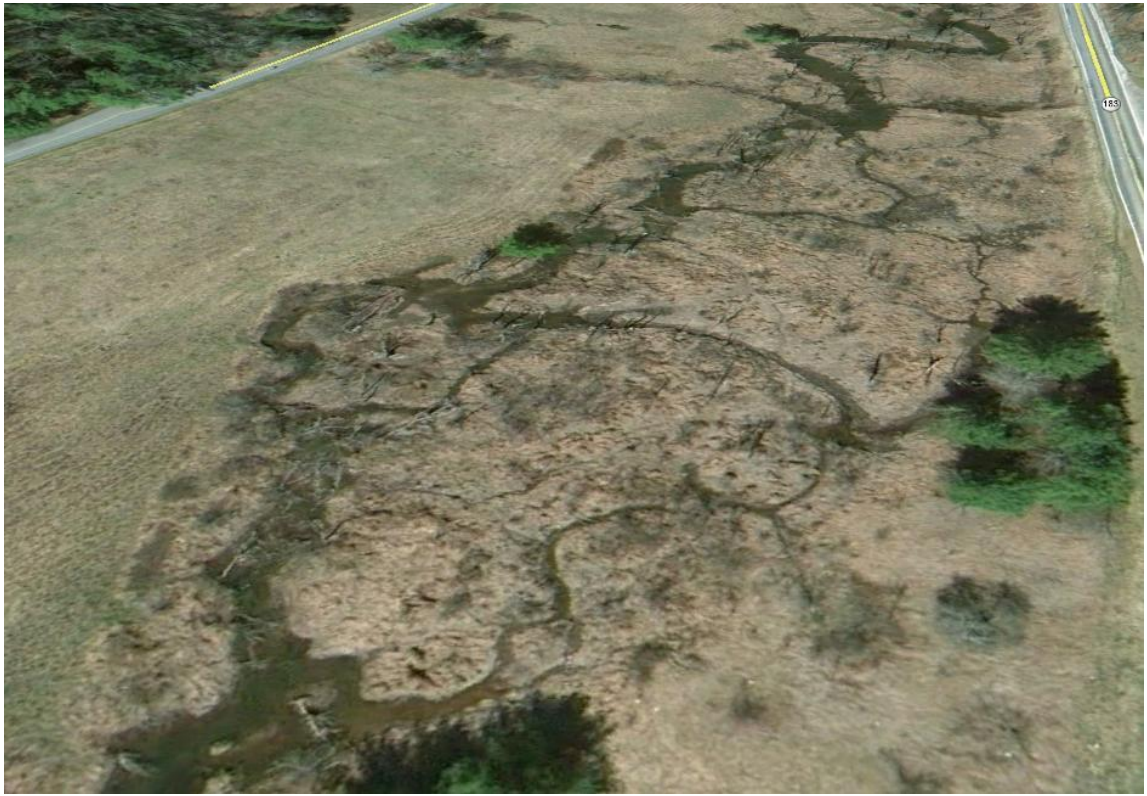
By 2011 the dams in this reach had been abandoned and the ponds drained, leaving a network of anabranching channels through the former pond areas. Herbaceous vegetation has colonized the area, though woody growth is just beginning. (Figure A24.) Woody growth (primarily Hazel Alder (*Alnus serrulata*) has moved in extensively by 2013, and the former pond area has an extensive series of channels through it, visible in Figure A25.

Figure A24. 2011 Aerial Photograph of Site M3 Lower Reach. (Google Earth)

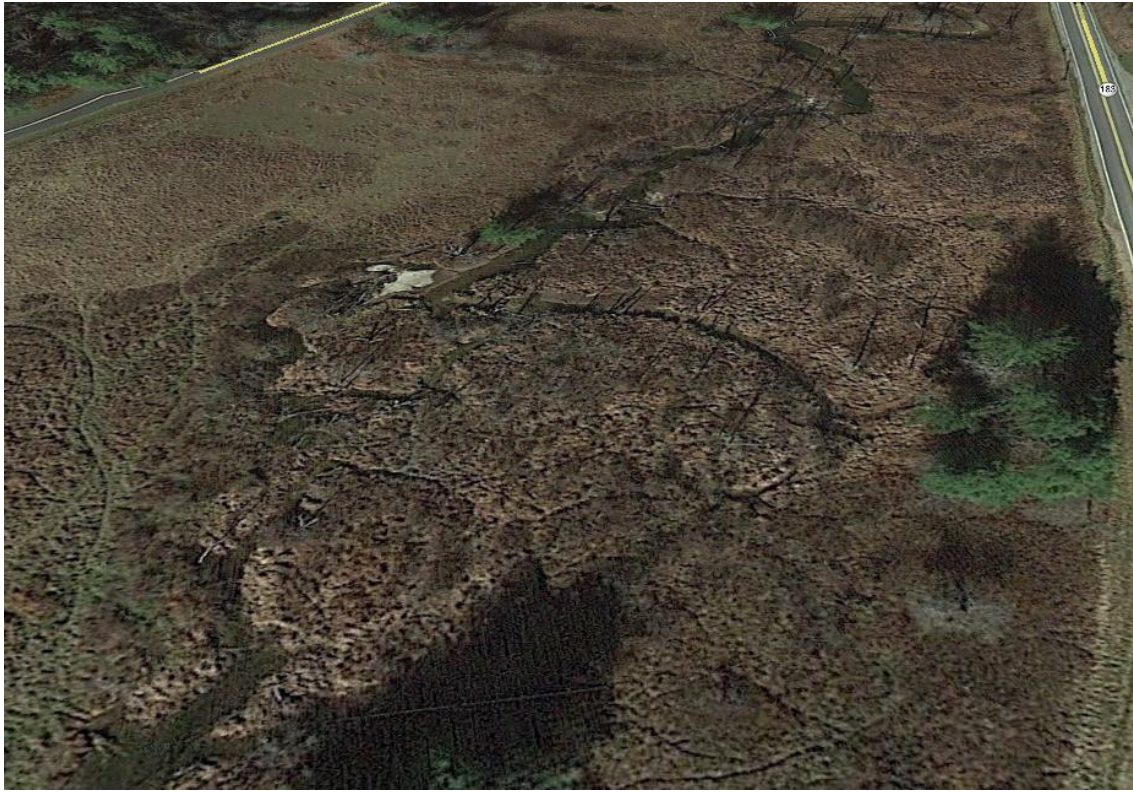
Figure A25. 2013 Aerial Photograph of Site M3 Lower Reach. (Google Earth)

As of this writing, the site is well-covered with both herbaceous material and Hazel Alder (*Alnus serrulata*), though no recruitment of larger hardwood or softwood species has been noted. Several anabranches have lost water sources and remain as ephemeral channels, several have remained stable, and several have consolidated into larger channels. The ephemeral channels have become well-covered in grasses and forbs, and appear to be stable, erosion-resistant elements of the landscape at this time.

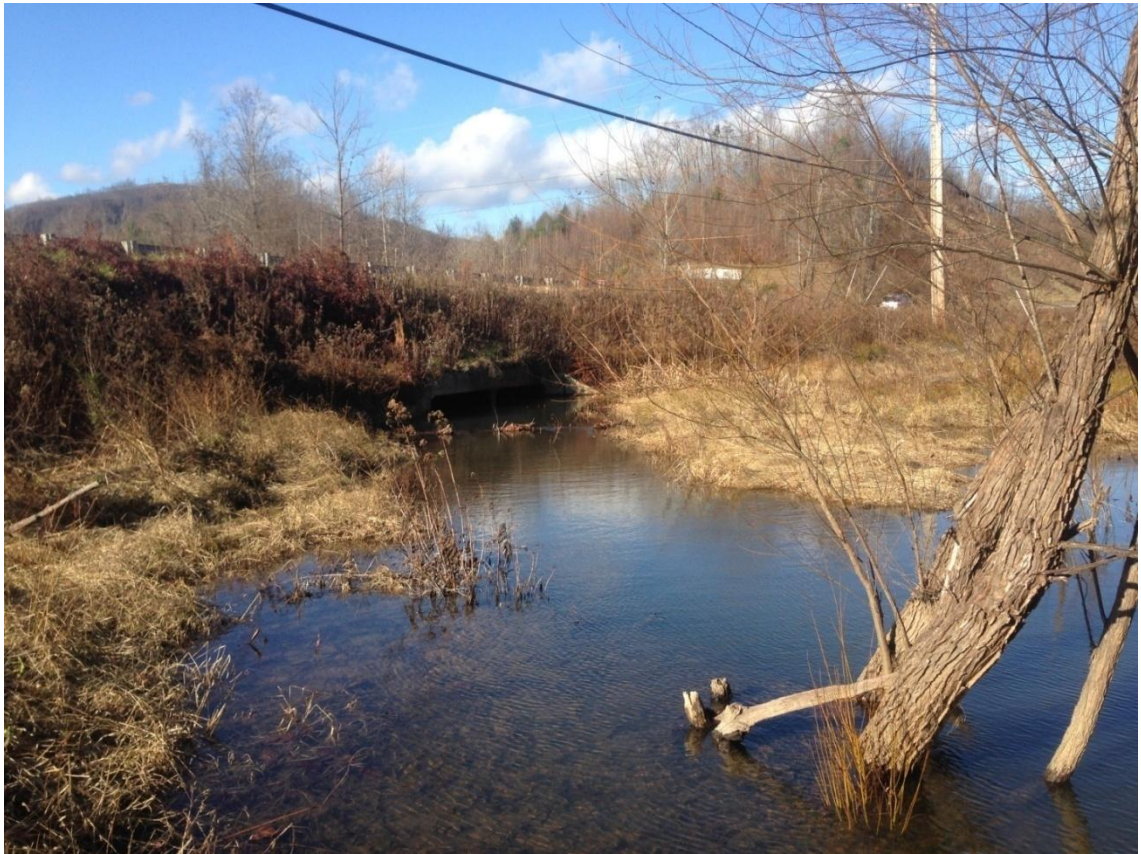
M4 consists of 4 primary dams and 3 wing dams, impacting 275 m of Conely Branch in McDowell County, NC, adjacent to NC 221. Beaver activity began on this site in approximately 1999, and the site remains active. The upper limit of this complex is a culvert under NC 221 (figure A27), thus preventing any direct upstream movement of the dam complex..

Figure A27. Culvert “Headwater” for Site M4. (Author)

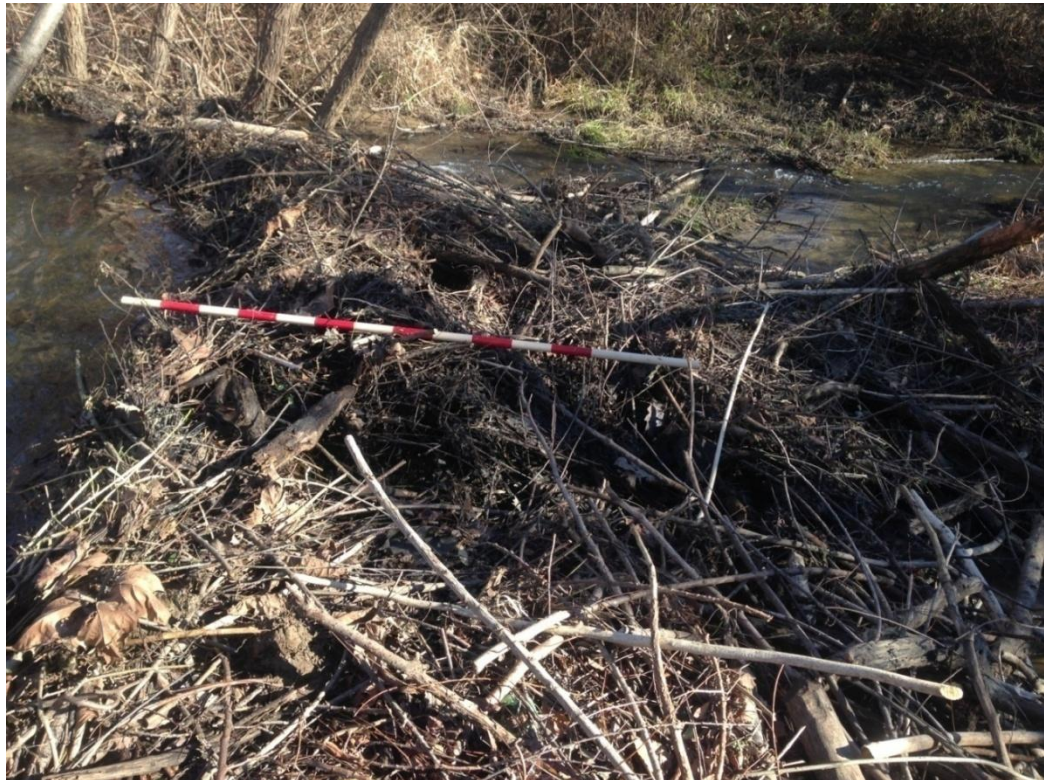
Figure A28. Lower Dam at Site M4, showing Heavily Wooded Downstream Face, though underlying Dam is primarily Beaverlith. (Author.)

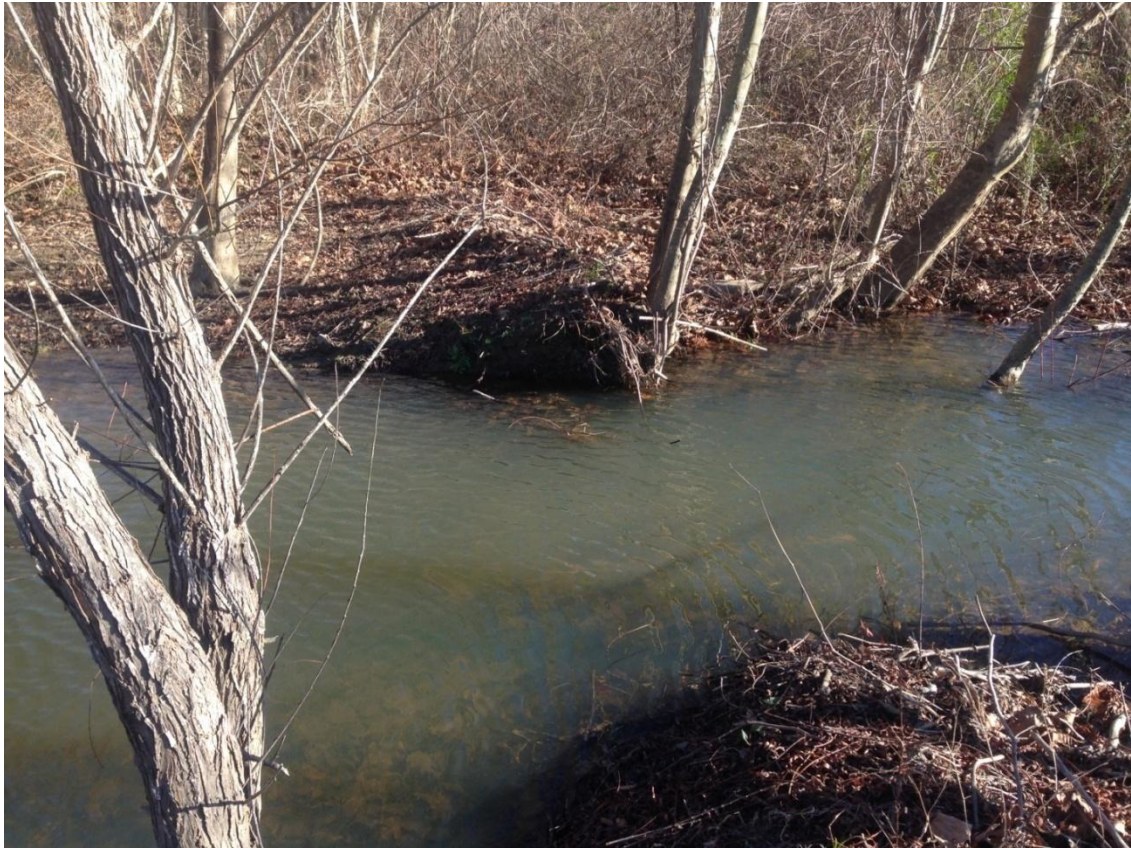
Figure A29. Breached Beaverlith Dam, width 1.9 m at Waterline. Note gentle Slope on the Upstream (left in photo) Face, with much shaper slope on Downstream Face. This Profile is a result of Woody Material on the Lower Face being removed during High Flows, while the erosion-resistant Beaverlithic Material, including Woody Debris incorporated into the Beaverlith, remains.
(Author)

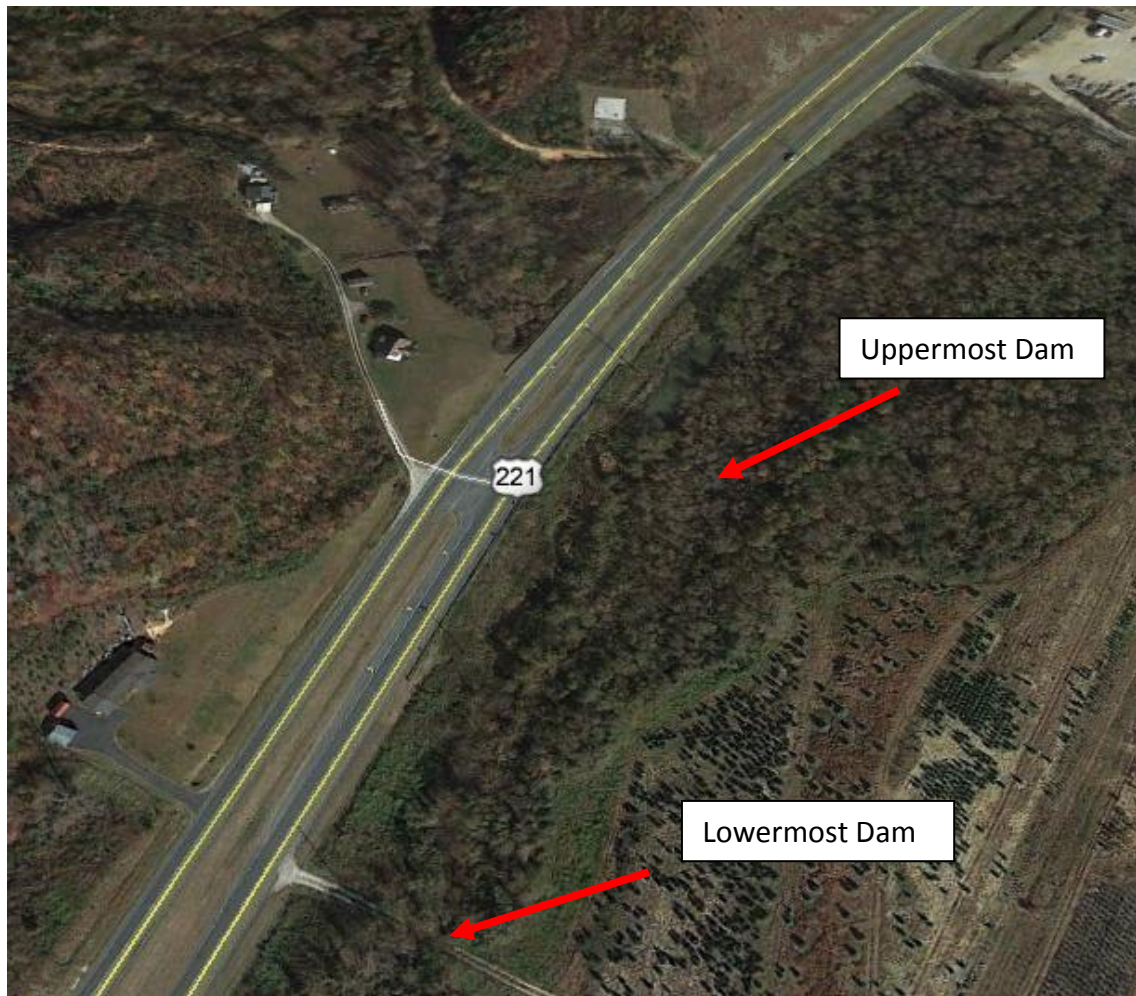
Figure A30. The 2013 Aerial Photograph shows the extent of the Site, paralleling NC 221 on the west (left side.) (Google Earth)

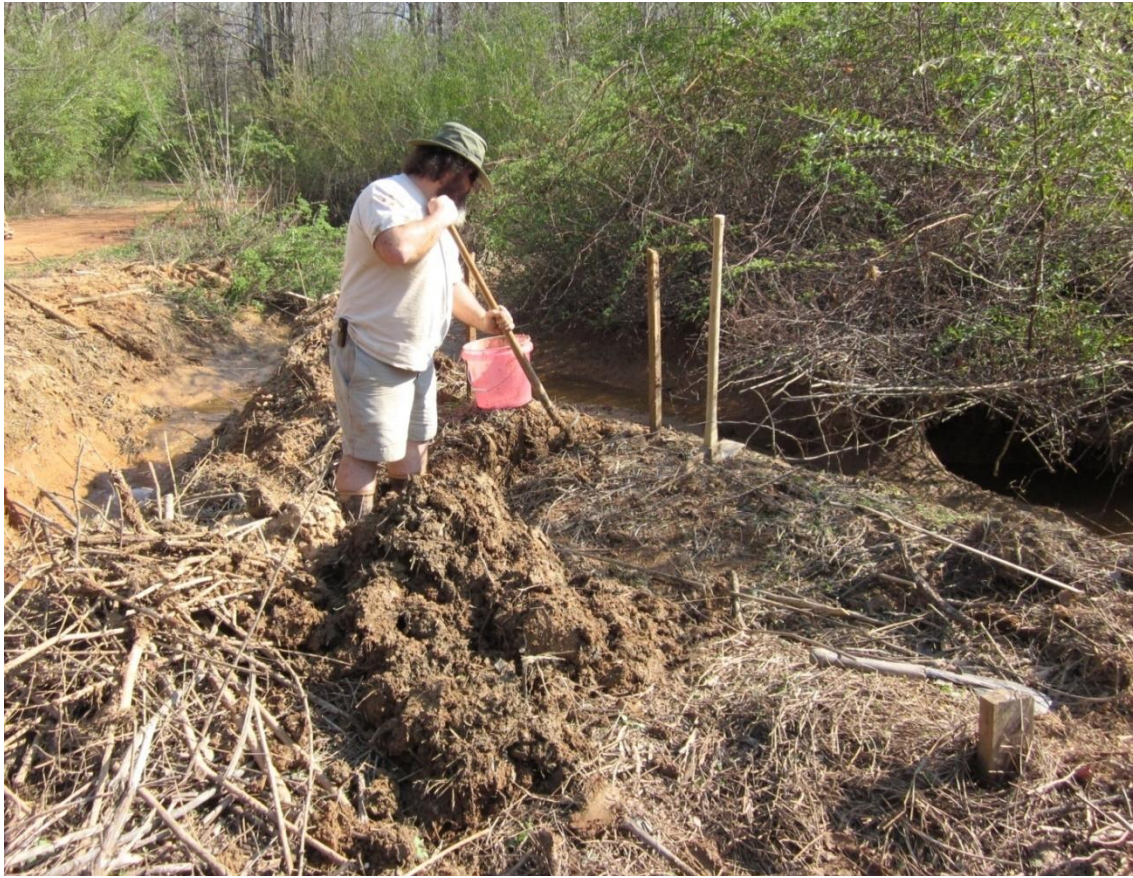
Figure A32. Excavating a Transect across a Beaverlith Dam. (Author)

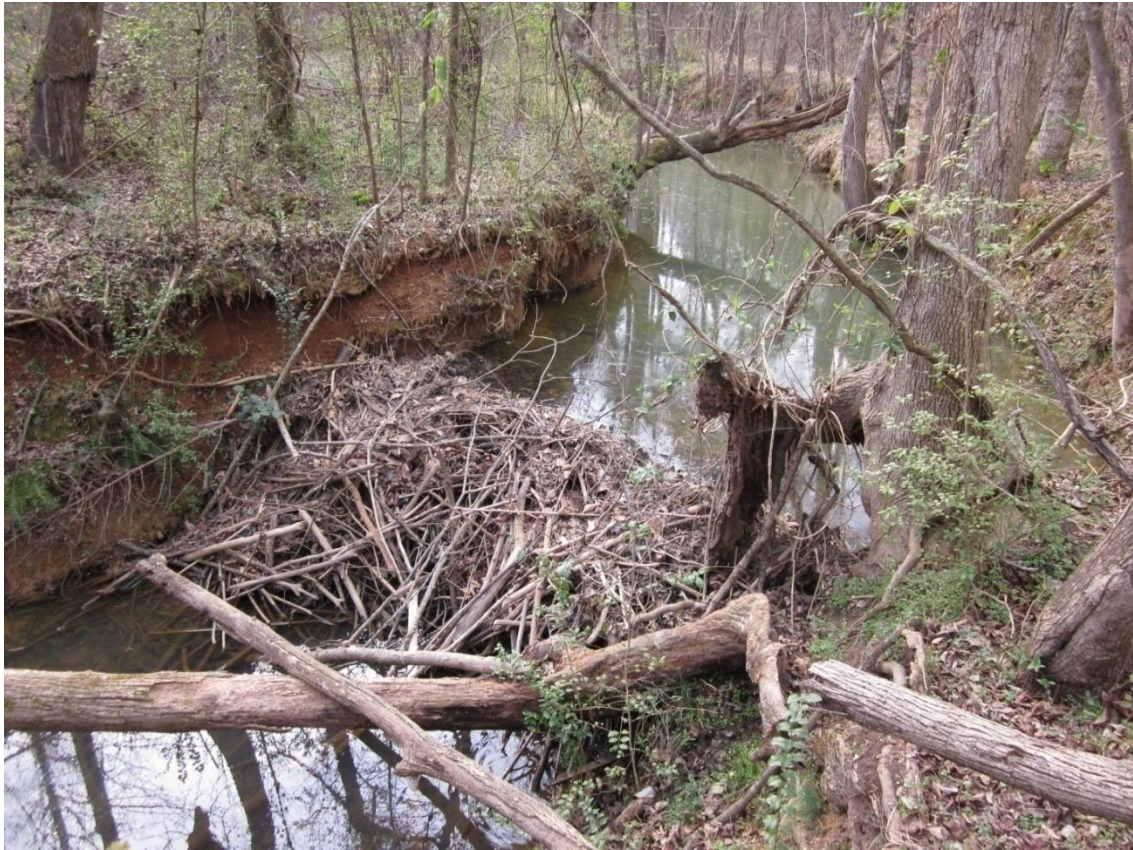
Figure A33. Wattle and Daub Dam in Incised Stream. (Author)

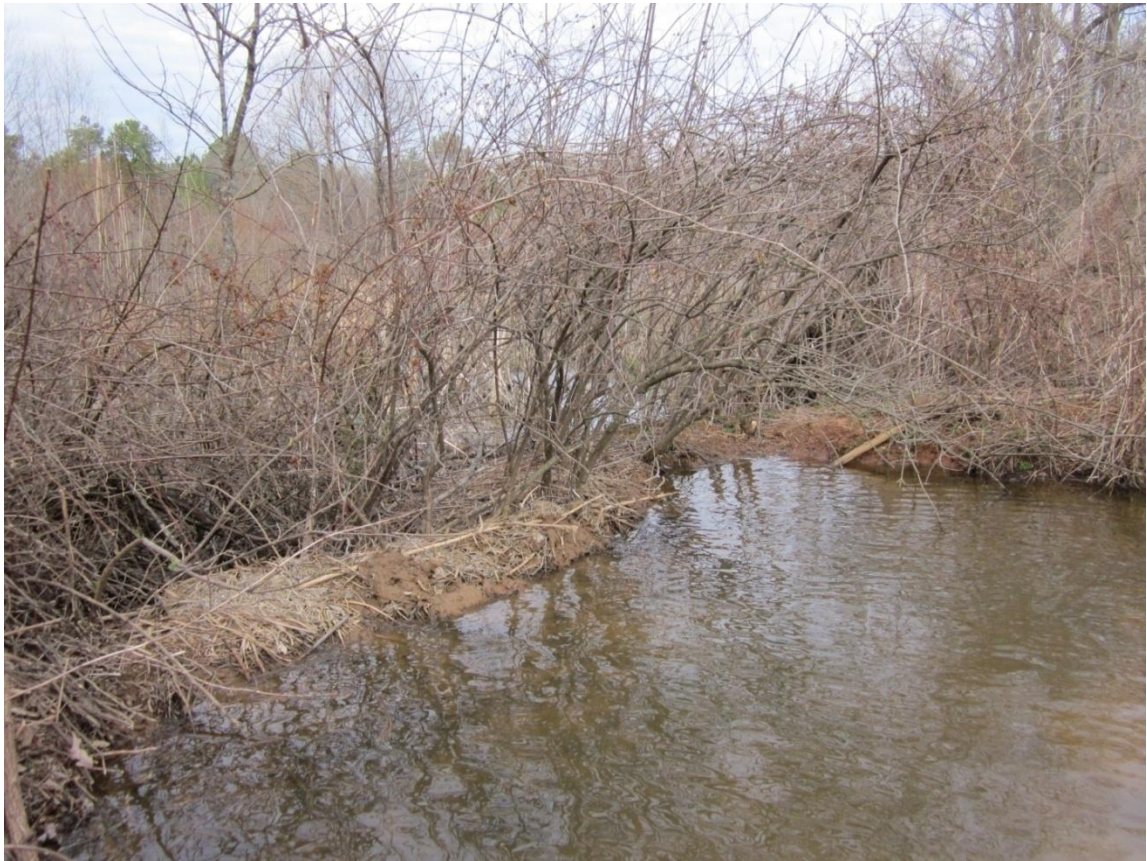
Figure A34. Portion of First Main Beaverlith Dam; note Vegetation growing on Dam. (Author)

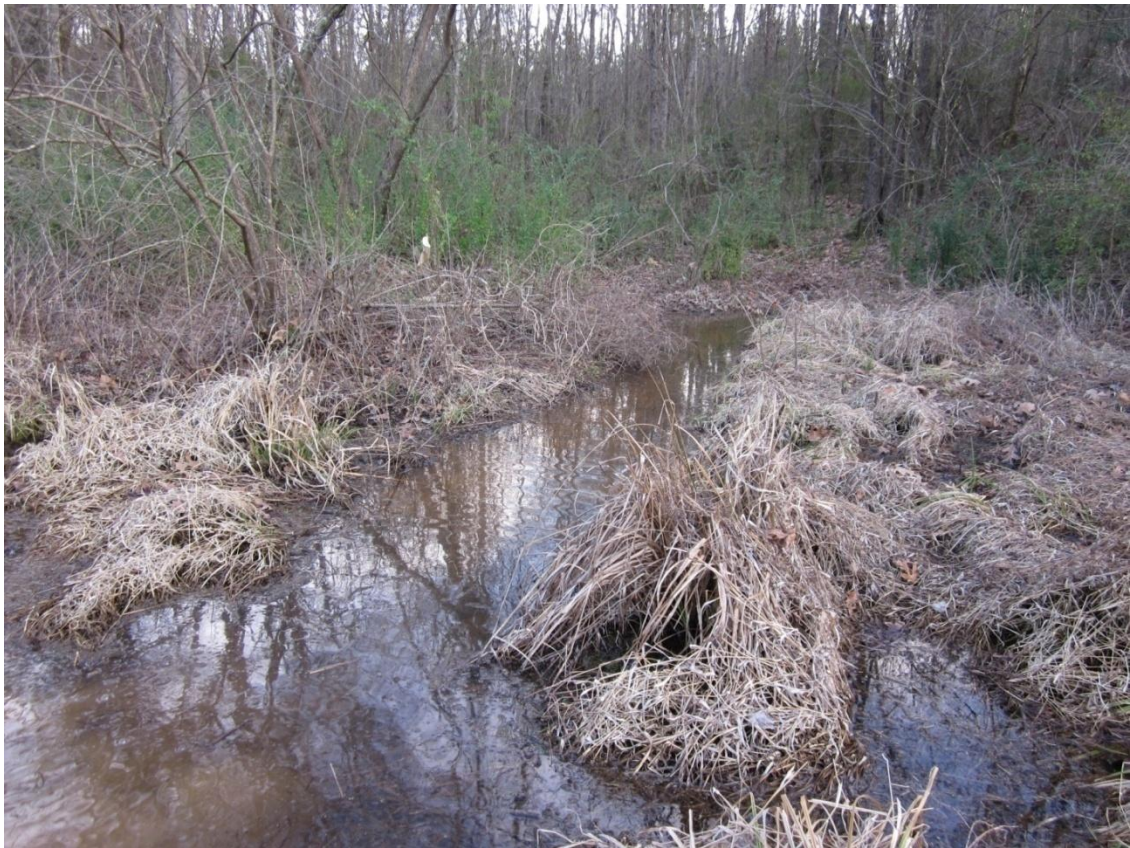
Figure A35. Beaver Canal. (Author)

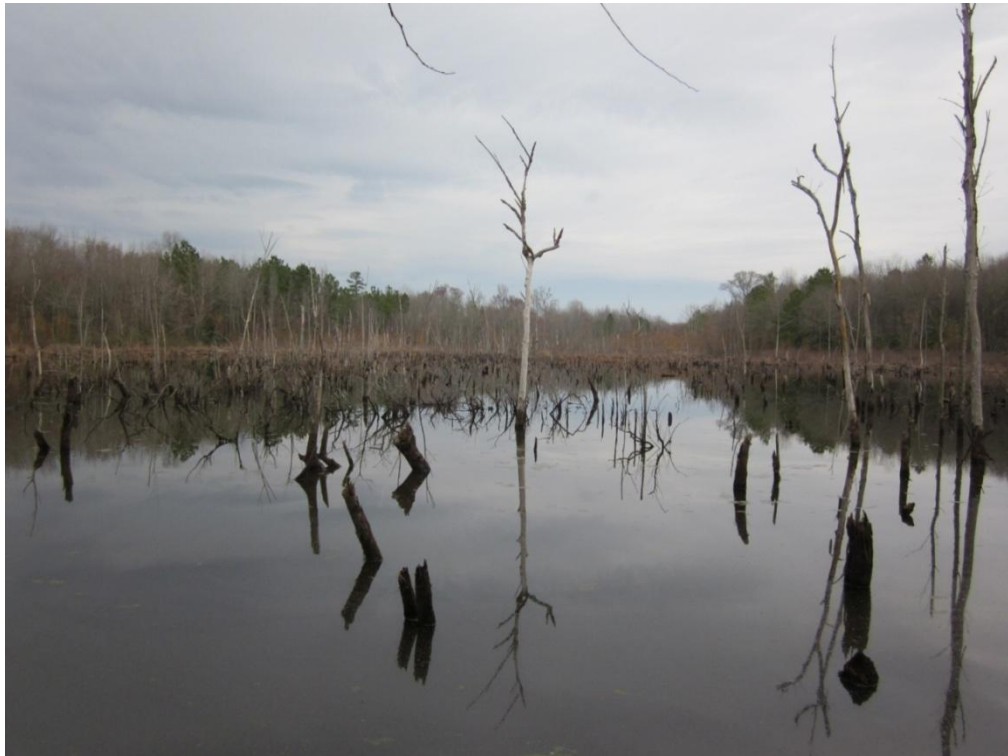
This site, on the northern fork of the tributary, consisted of only two dams, one wattle and daub and one beaverlith, though the wattle and daub dam contained far more soil material than other dams of that type in this study. The upper dam was located in a washed-out section of former roadbed built across the tributary, likely the location of a culvert many years prior. This created an ideal situation for damming, as little effort was required to flood a considerable area of land, just under 2 hectares (Figure A36.)

Figure A36. Upper Pond of P1b. Filled with Stumps of Beaver-cut Trees. (Author)

Other than the size of the pond and number of beaver-cut stumps in the water, this was an unremarkable dam, as no anabranches were formed in the focused outlet. However, if activity continues without anthropogenic interference, the pond will likely top the old roadbed, which will likely result in numerous anabranches. These, however, are the result of former anthropogenic activity and not solely a result of beaver action.

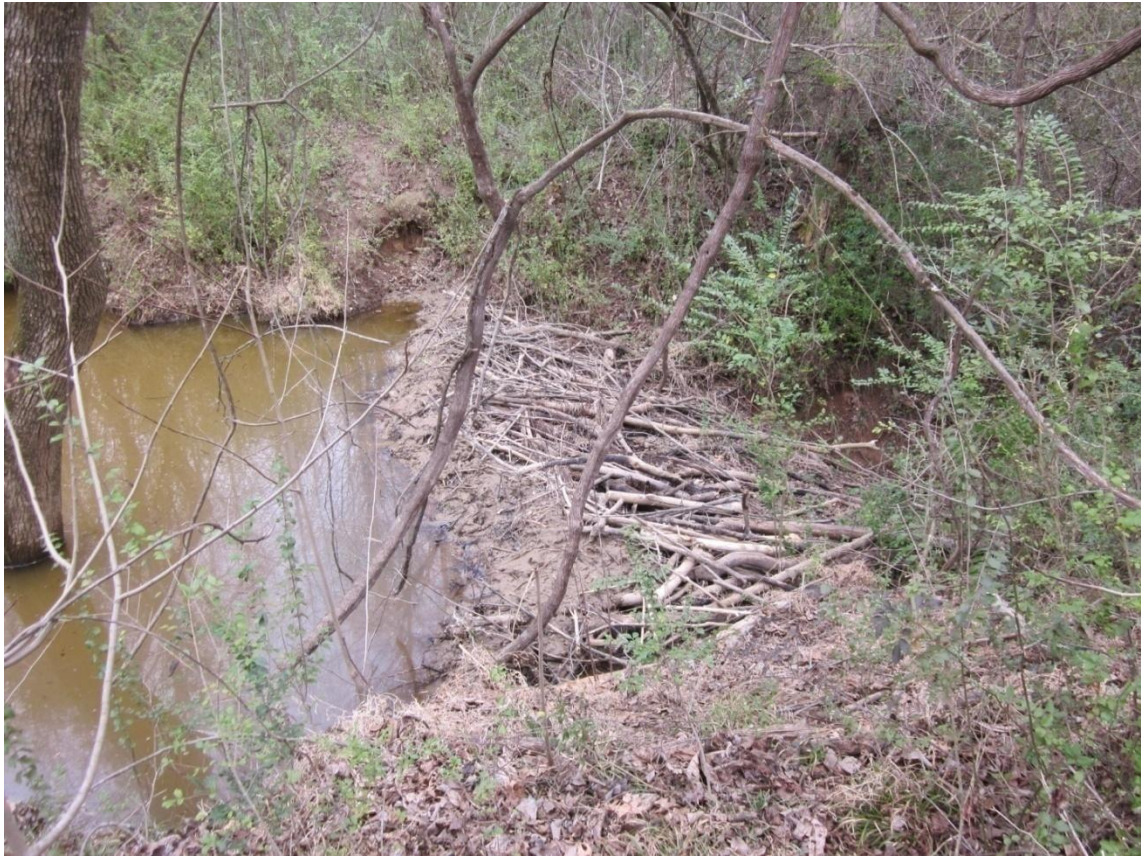
Figure A37. Top of large Beaverlith Dam. (Author)

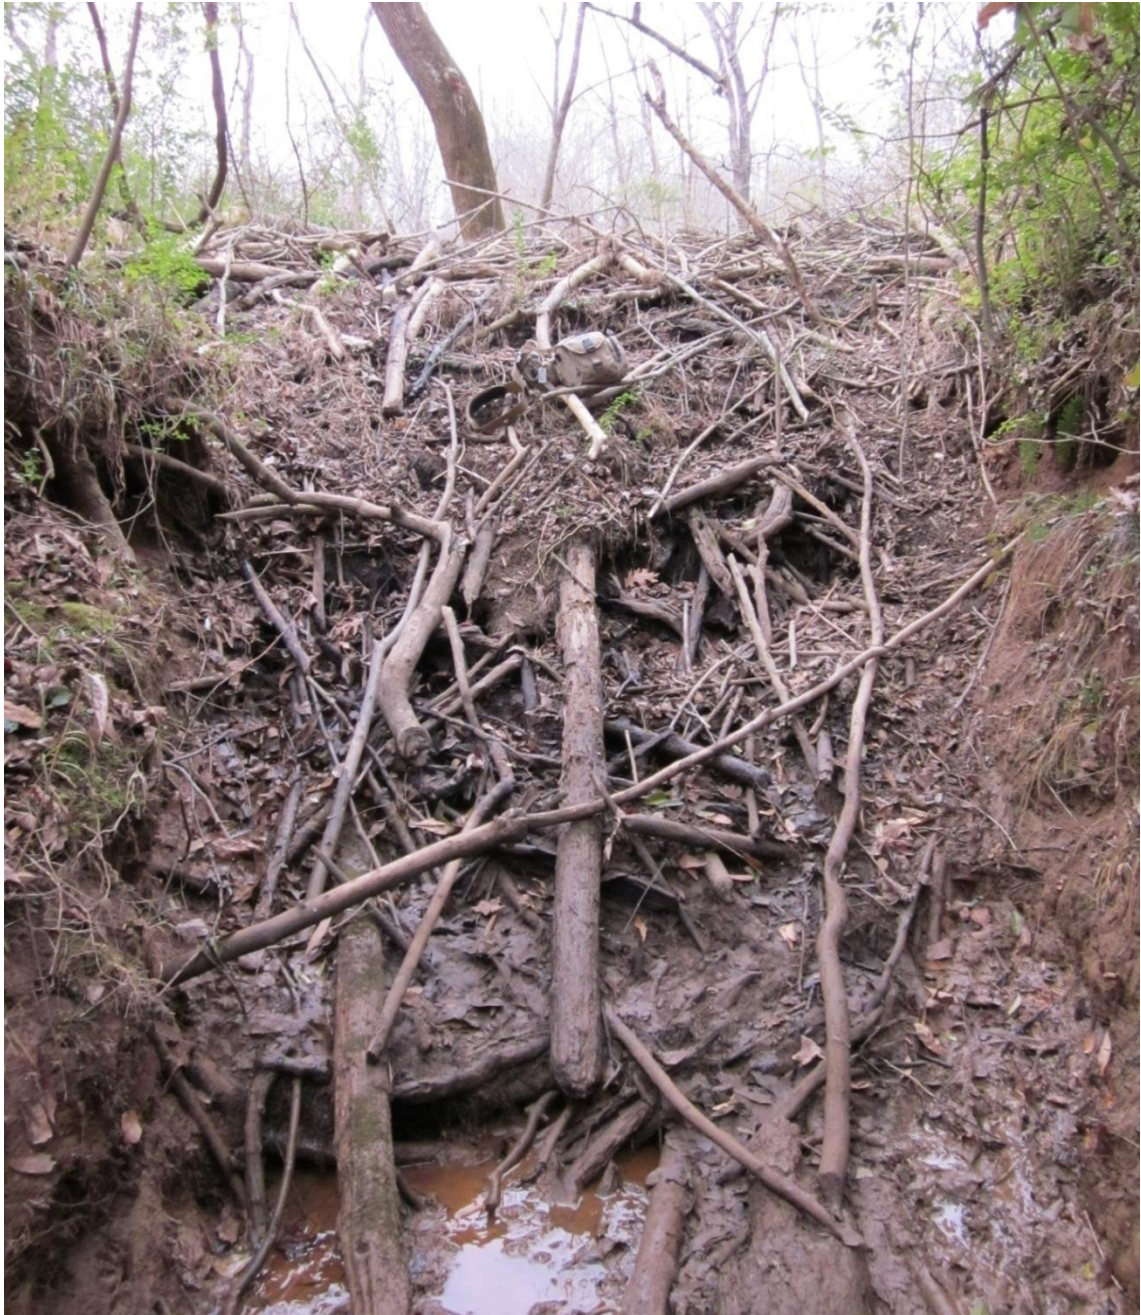
Figure A38. Downstream Face of large Beaverlith Dam. (Author)

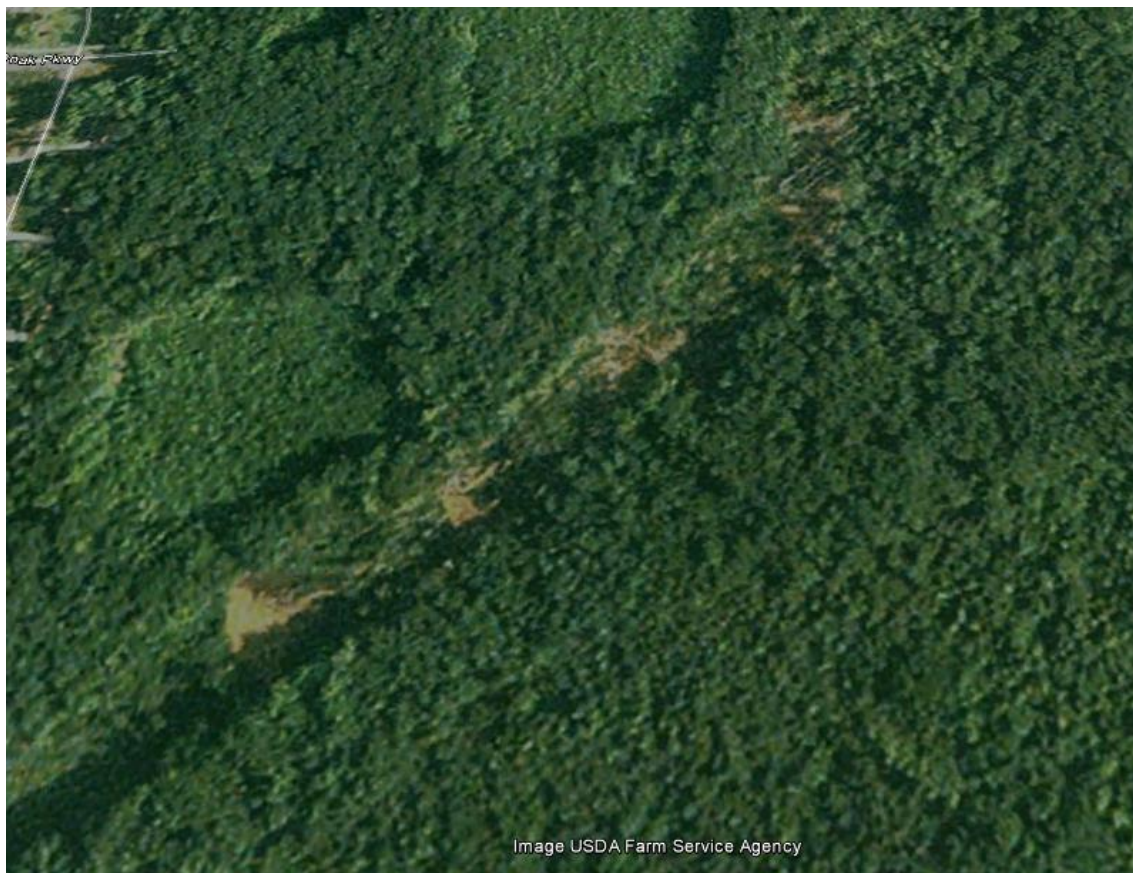
anabranching channel systems to form below each dam in the waterlogged but uncovered area between dam and pond. As the aerial photo from 2008 (figure A40) shows, the dams were originally spaced at some distance on the streams; by 2013 the trees in the inter-dam zone have died or been cut, leaving an exposed network of channels between dams (figure A41.)

Figure A40. 2006 Aerial Photograph showing Development of Dam Sequence and Spacing. (Google Earth)

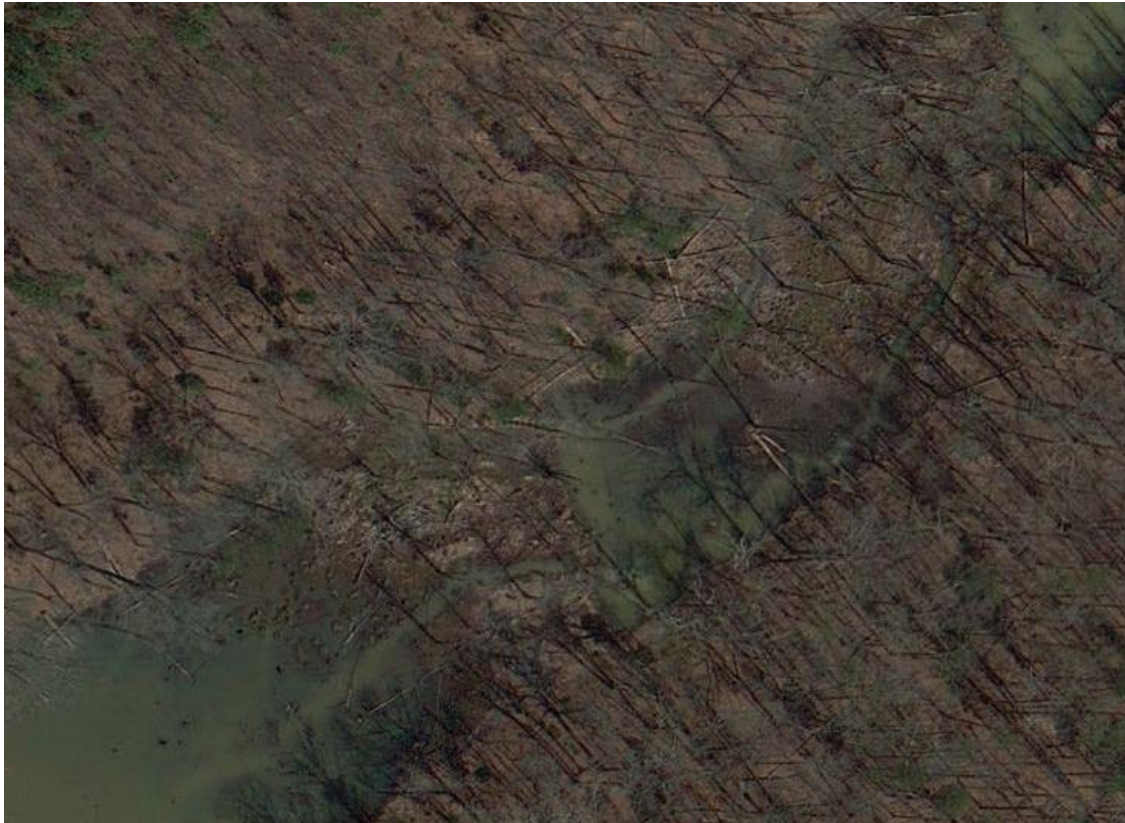
Figure A41. 2013 Aerial Photograph showing loss of Trees in Inter-Dam Zones, and Anabranching Channel System Form. (Google Earth)
